Manhole Inspection Summary

Manhole # S29II_021MH

Insp Date: **10/29/07 10:23 AM**

Location Address: **1801 BOLTON ST**

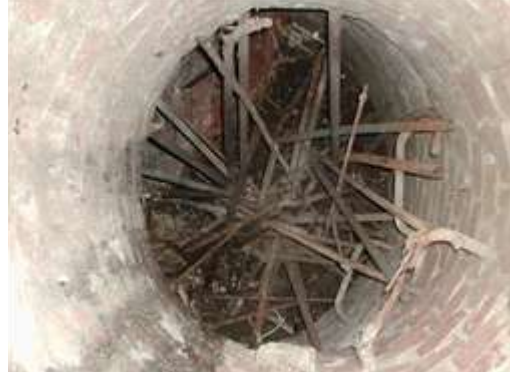
Top View

Corroded and missing steps. Channel debris.

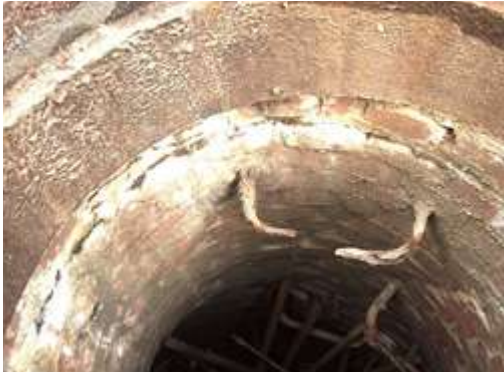
Defect

Frame leaks. Adjustment deterioration and infiltration. Corbel infiltration - other side.

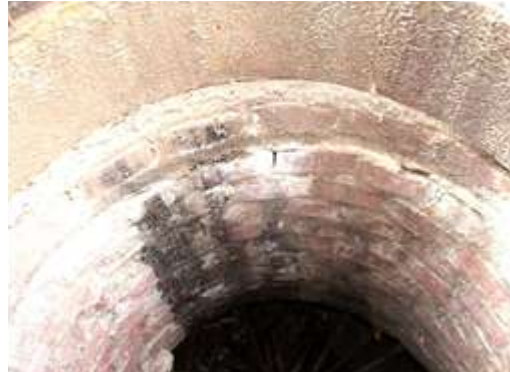
Defect

Frame leaks. Adjustment deterioration and infiltration. Corbel infiltration.

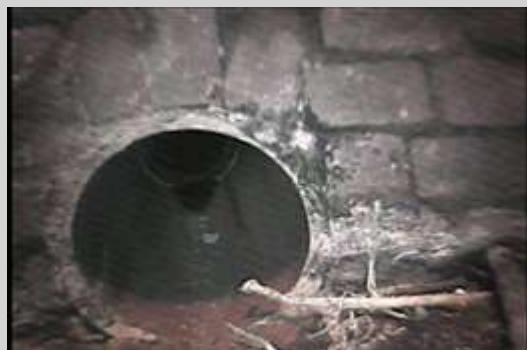
Pipe Out @ 12 O'Clock

Infiltration: **Evidence**
